# Manhole Inspection Summary

Manhole # S43CC\_102MH

Record Plat: **43CC** Node: **102** Status: **New Manhole (Not in GIS)** Insp Date: **12/19/07 12:00 AM**

**Location** Address: **n.broadway st**

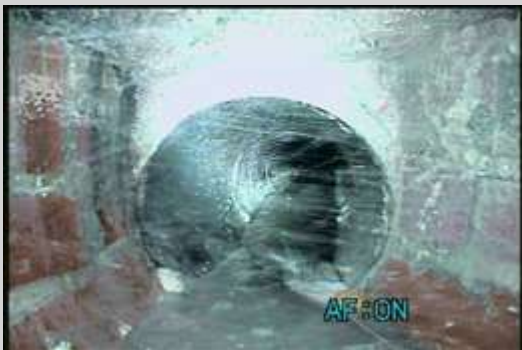
12 O'Clock Outflow

Pipe Material: **Clay** ☐ Pipe Lined

Invert Depth: **13.30** (ft.) Flow Characteristics: **Fast**

Deposits: ☒ None ☐ Mud ☐ Sludge ☐ Debris ☐ Grease

Infiltration: **None**

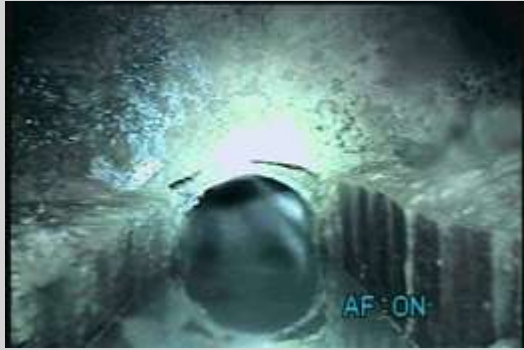
6 O'Clock Inflow

Pipe Material: Clay ☐ Pipe Lined

Infiltration: None
